Impression Inspection Checklist

Overall quality of Impression

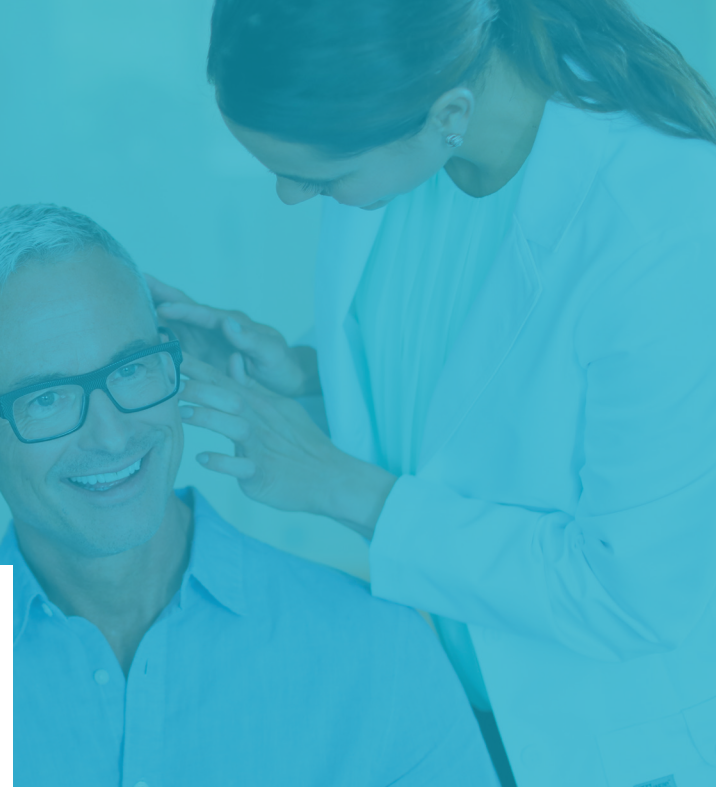
- Canal length (Image 1)
 - long enough to determine sound direction
 - IIC or CIC- canal at 2nd bend
- Full concha bowl (Image 2)
 - Shallow concha bowl may not be ITC R candidate
- Full helix (Image 3)
- No voids
- No narrow aperture
- Sharp bend in ear canal
 - May not be IIC or CIC candidate

1 Canal length

2 Concha Bowl

3 Helix
