# Impression Inspection Checklist

## Overall quality of Impression

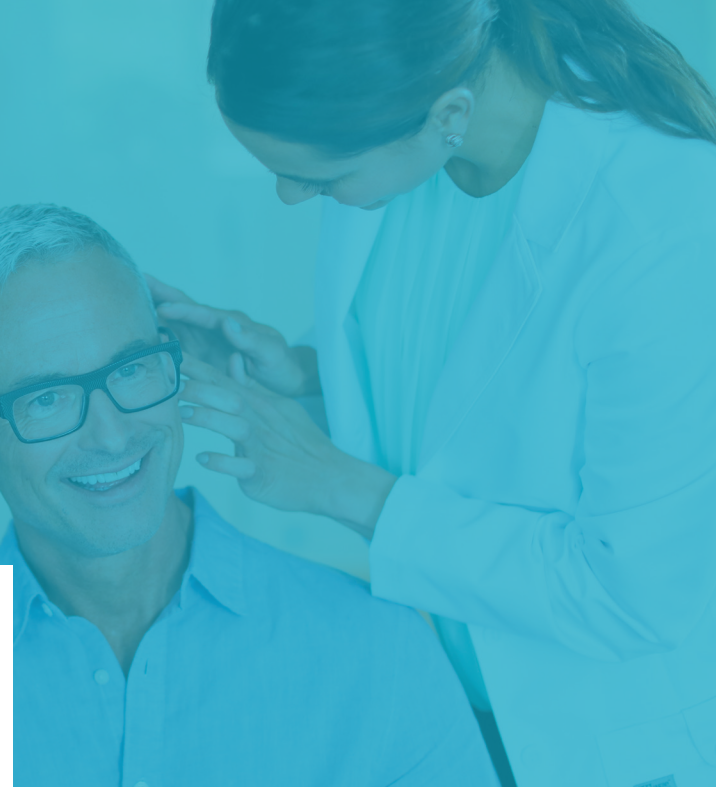
- Canal length (Image 1)
  - long enough to determine sound direction
  - IIC or CIC- canal at 2nd bend
- Full concha bowl (Image 2)
  - Shallow concha bowl may not be ITC R candidate
- Full helix (Image 3)
- No voids
- No narrow aperture
- Sharp bend in ear canal
  - May not be IIC or CIC candidate
